A Summary of a NIOSH fire fighter fatality investigation

Fire Fighter Dies After Being Run Over by Ladder Truck While Attempting to Board—Alabama

Fatality Assessment and Control Evaluation Investigative Report #F2000-41

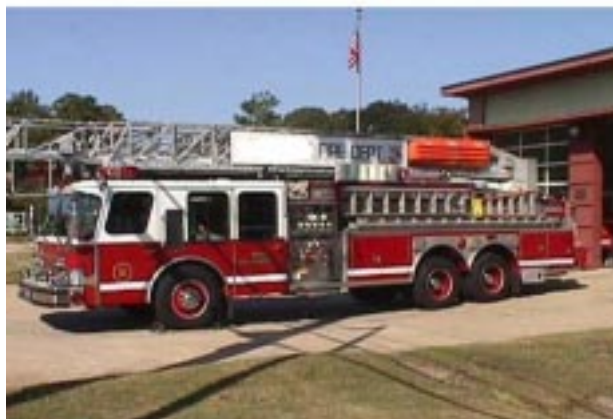
Ladder Truck Involved in Incident

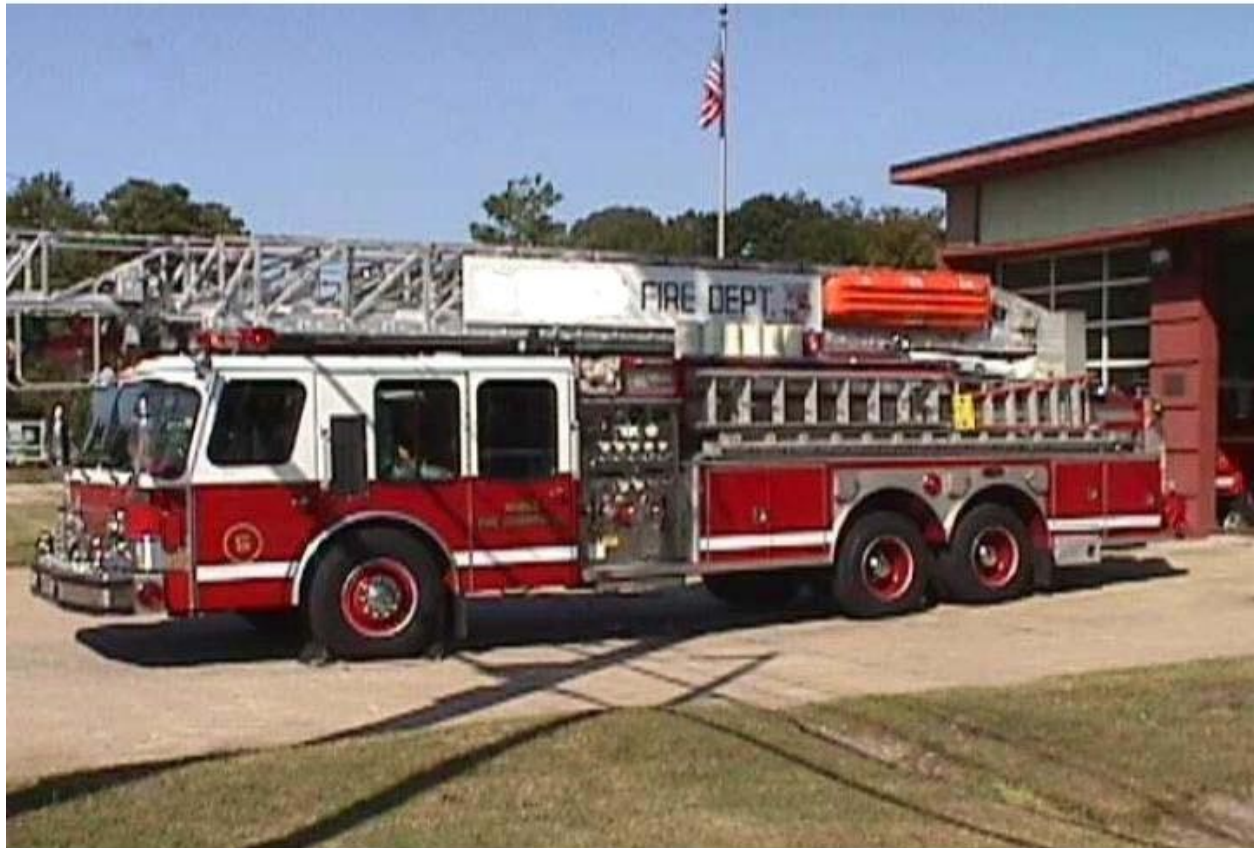
Photo 1. Ladder Truck Involved in Incident

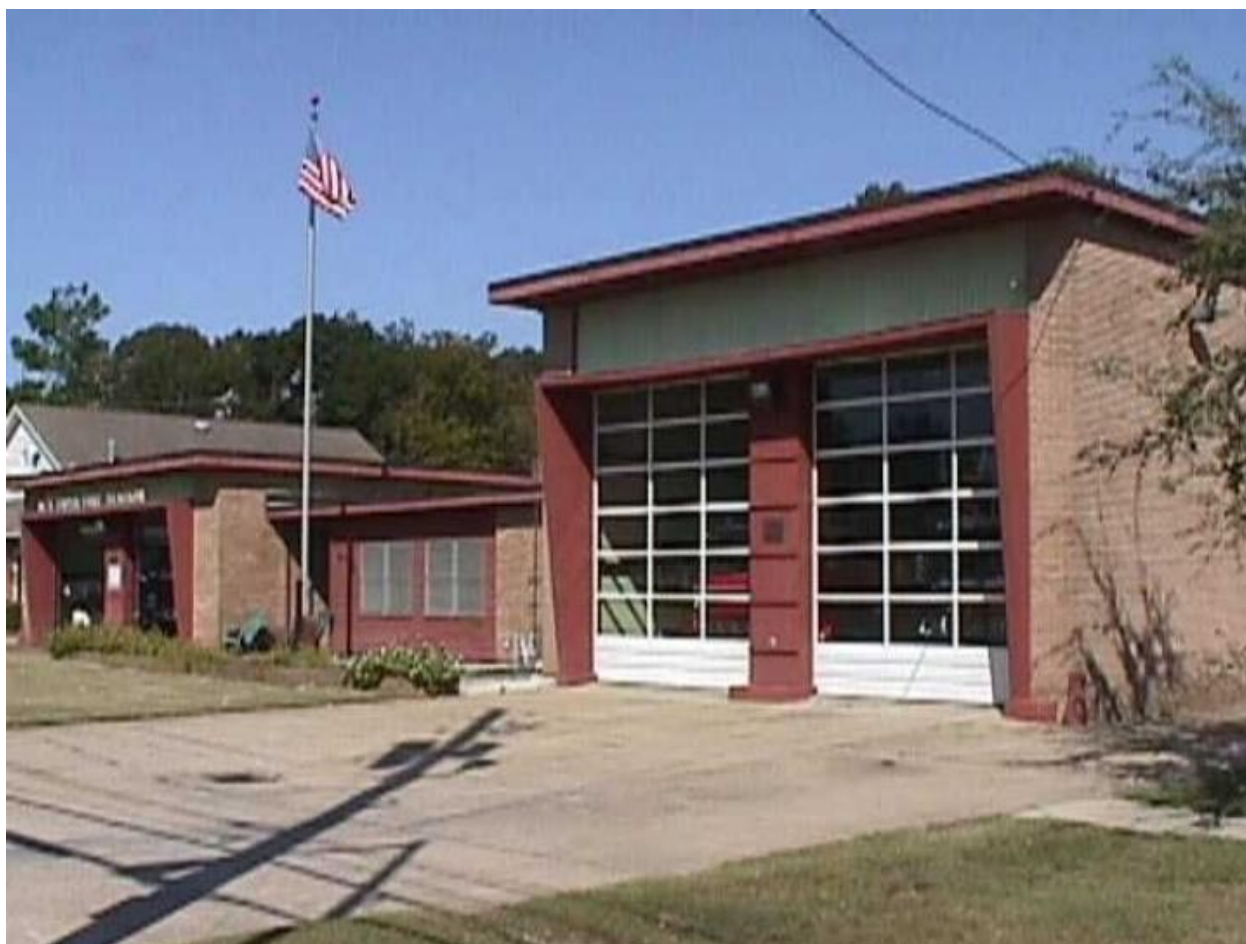
Photo 2. Station's Driveway Apron

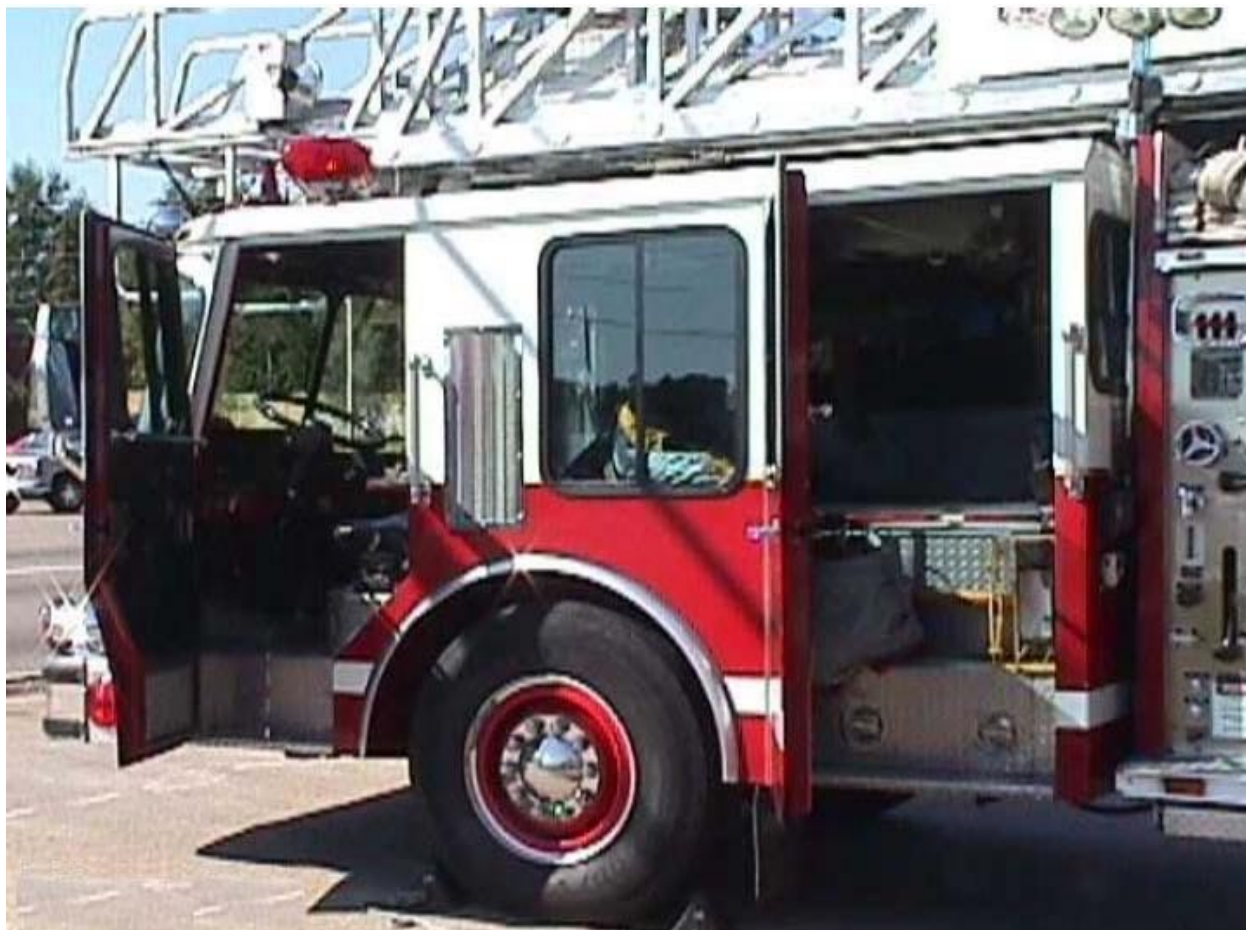
At the fire station, responding fire fighters should quickly assemble on the apparatus floor near the vehicle and don protective clothing, and mount the apparatus while it is stationary. Jumping onto or off moving apparatus is inherently dangerous. If the fire fighter misses the step of the moving fire or emergency apparatus, as was the case with this incident, and falls to the roadway, chances are great that the rear wheels will run over the fire fighter before the driver can stop the vehicle.

Photo 3. Jump-Seat Door That Victim Was Attempting to Board

ensure that fire fighters do not attempt to board moving fire and emergency apparatus.¹

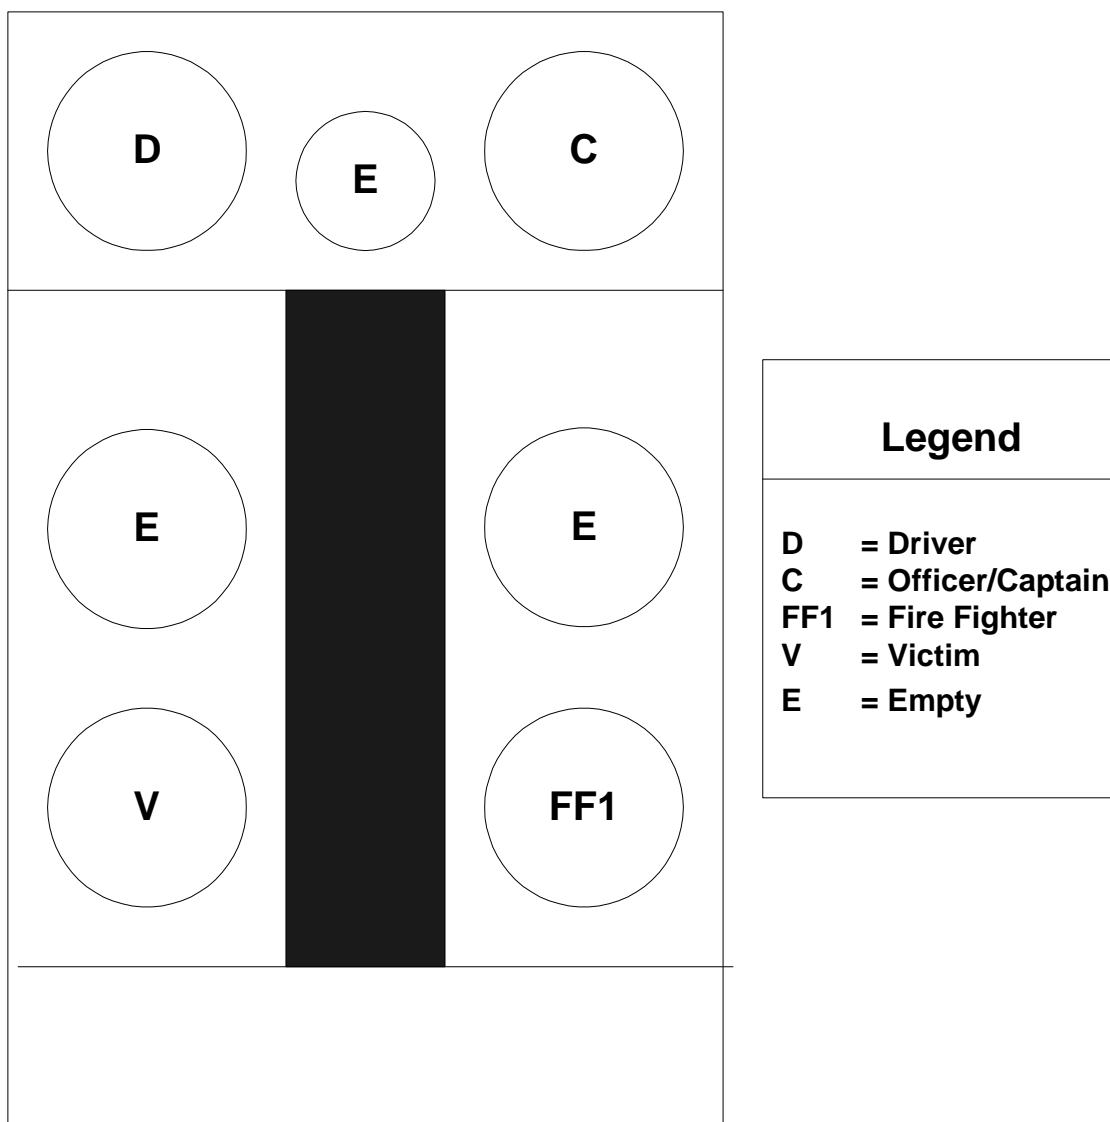
All of the riders on the apparatus should be seated within the cab or body of the emergency or fire apparatus and should be wearing their seat belts before the vehicle is put into motion. The officer (Captain) must always be assured that all fire fighters are properly and safely boarded before giving the order to proceed (i.e., visual contact, verbal contact, or giving personal accountability tags to the officer once on board). At the time of the incident, the fire fighter seated in the jump seat behind the Captain could not see if the victim was on board in the other jump seat because his vision was obstructed by the engine cover on the truck.

Figure. Assigned Riding Positions on Ladder Truck

Recommendation #3: Fire departments should ensure that personnel on board emergency and fire apparatus are seated, belted, and accounted for, prior to movement.^{1,3,5}
